Professor Mitchell Gohnert

At your request, six concrete beams were tested at Wits University. The objective of the test was to determine the failure strength, and the load at which horizontal shear occurs. The beams were tested from 28d, starting 5th August to the 7th of August 2013. The span of the test specimens was 1800 mm and four point loads were applied to simulate a uniform distributed load. The results of the tests are given in Tables 1 and 2 below:

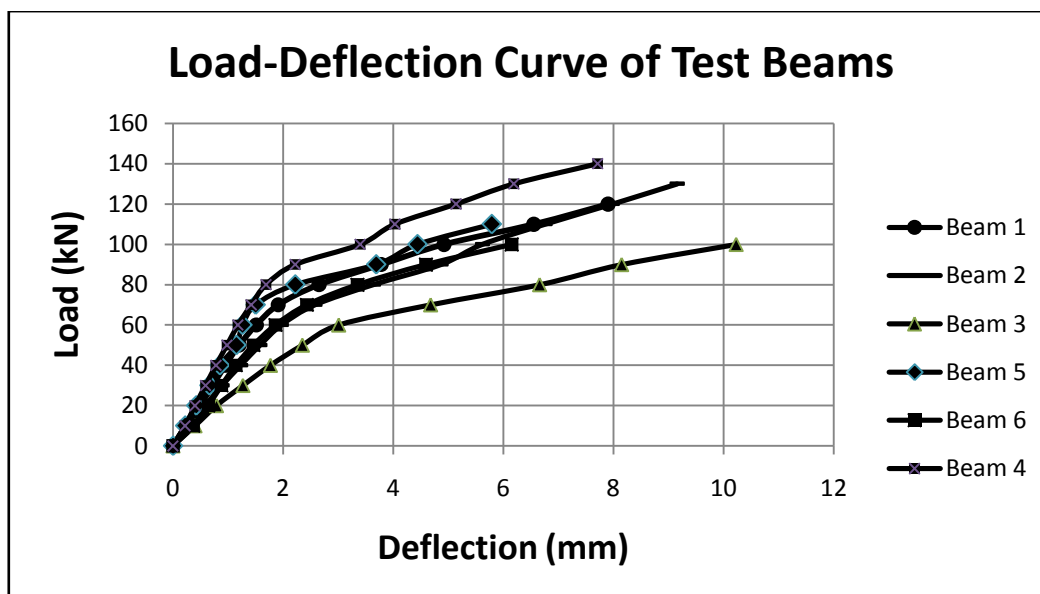
Figure 1: Load-deflection curve of test beams

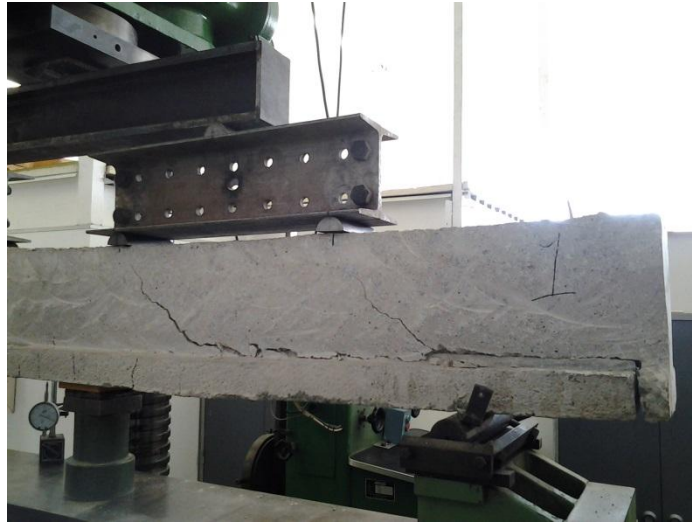
Figure 2: Failure pattern of test beam 1

Specimen	Rib Dimensions (Width x Depth) (mm)	Overall Dimensions (Width x O/A Depth) (mm)	Failure Load (kN)	Mode of Failure
Beam 1	155 x 60	100 x 270	126	Shear failure along interface
Beam 2	155 x 55	105 x 250	140	Shear failure along interface
Beam 3	150 x 50	120 x 230	107	Shear failure from load point to support
Beam 4	150 x 60	140 x 260	148	Shear failure along interface
Beam 5	150 x 60	150 x 250	120	Shear failure along interface
Beam 6	150 x 60	125 x 260	110	Shear failure from load point to support
Average	152 x 58	123 x 253	751	Shear failure along interface

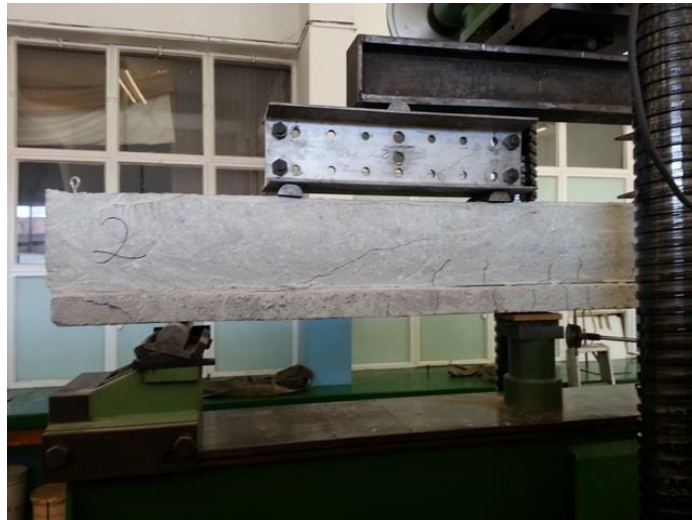
Figure 3: Failure pattern of test beam 2

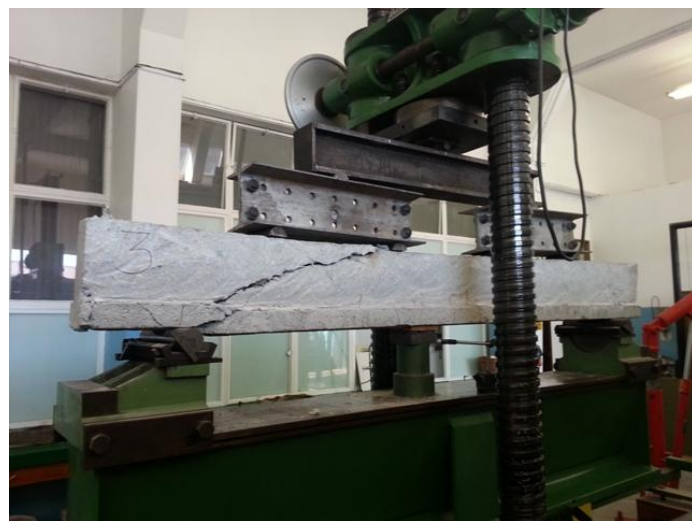
Figure 4: Failure pattern of test beam 3

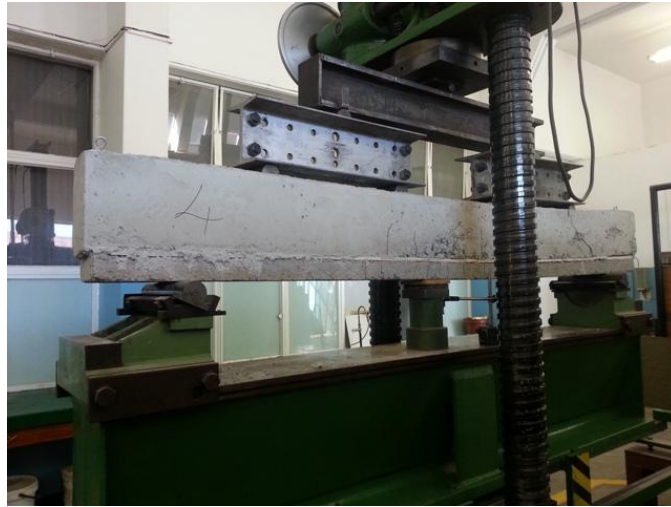
Figure 5: Failure pattern of test beam 4

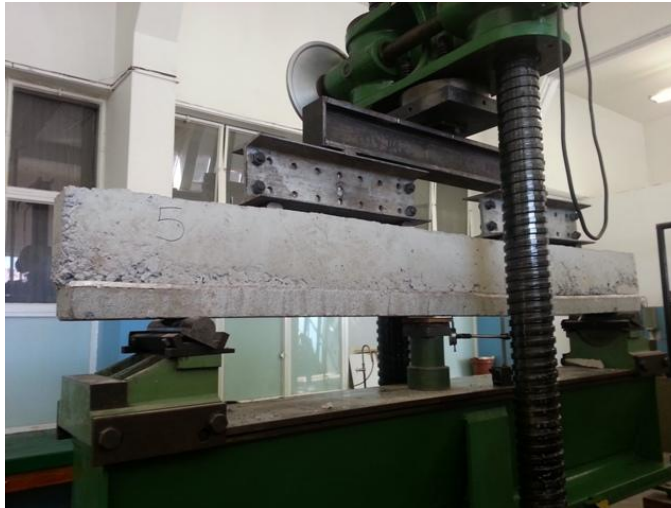
Figure 6: Failure pattern of test beam 5

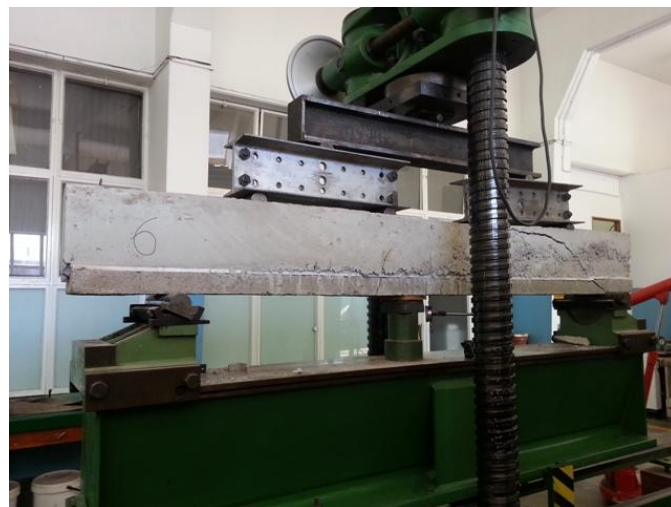
Figure 7: Failure pattern of test beam 6
